Good Gate Inc.

Accelerated Cycle Testing

84in High Carriage Gate

Date: April 30, 2018

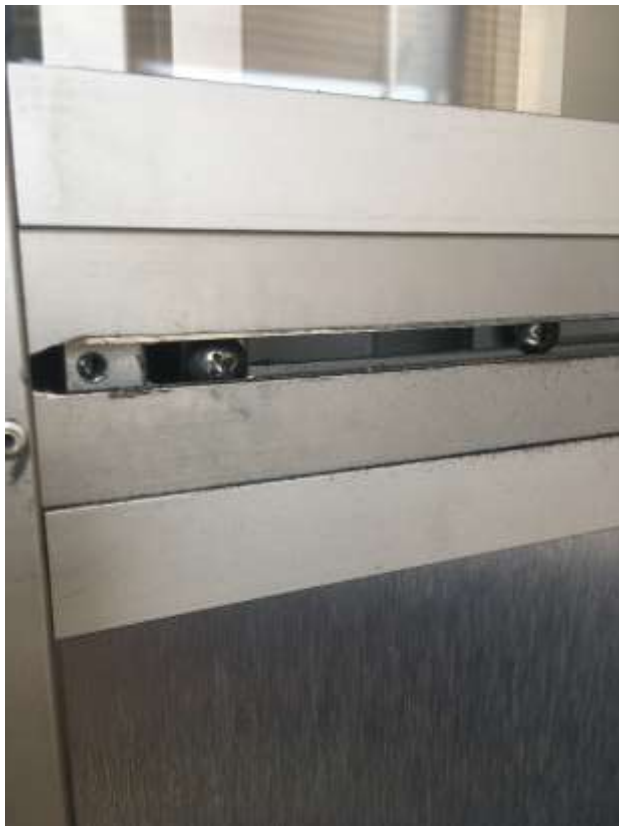
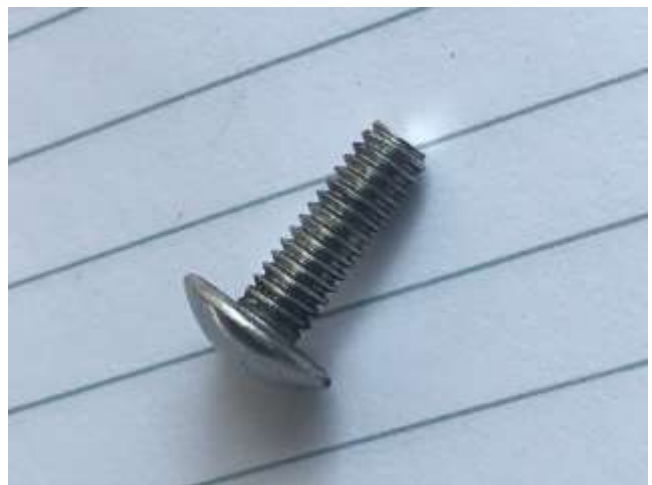
An intervention was required at roughly 8000 cycles when a scraping sounds was observed. Upon inspection the screw that goes through the slot on Panel #4 in inserts to Panel #3 was starting to dig in to the surface of the middle cross piece on panel #4. Once the screw was adjust to have slightly more clearance the sound went away and a further 3,407 cycles without any incident or intervention. Images showing this scoring can be seen below but no damage to the screw was observed.

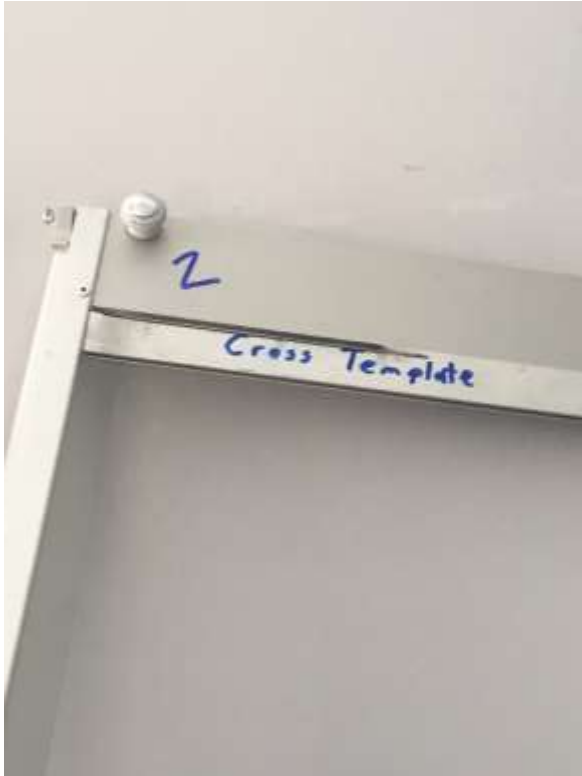
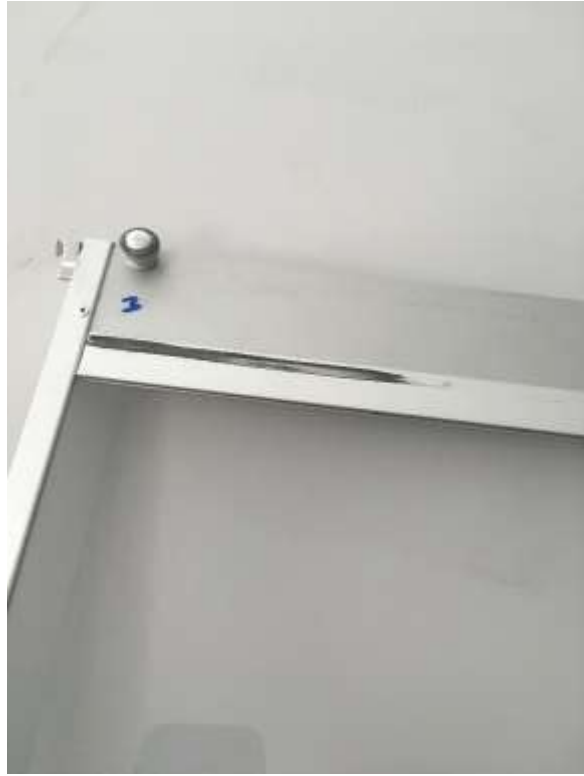
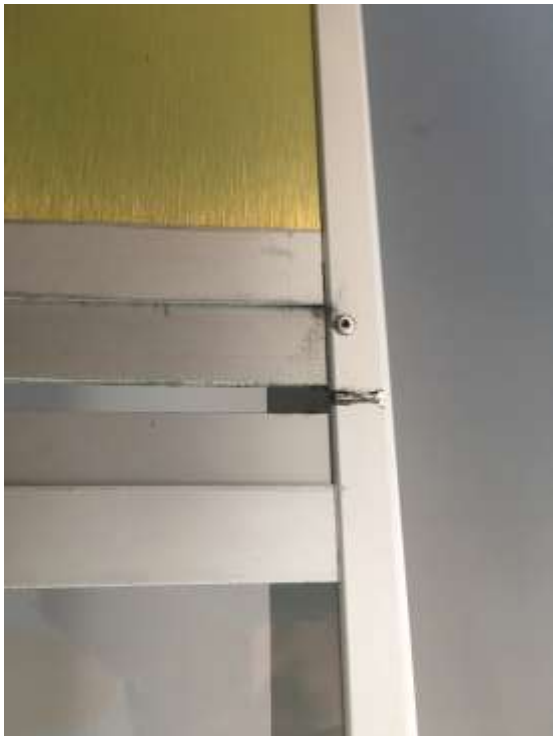
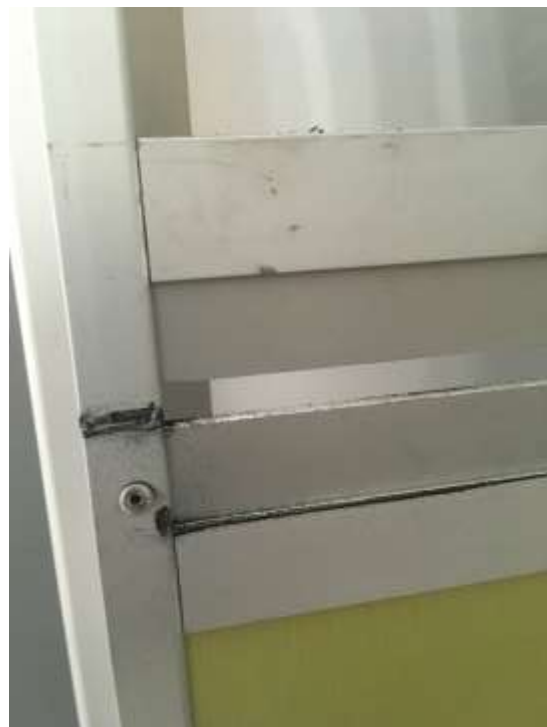
During disassembly and inspection there were several points of minor rubbing that were noticed but nothing that was significant or considered a failure.

Images of various areas of the gate panels are shown below.

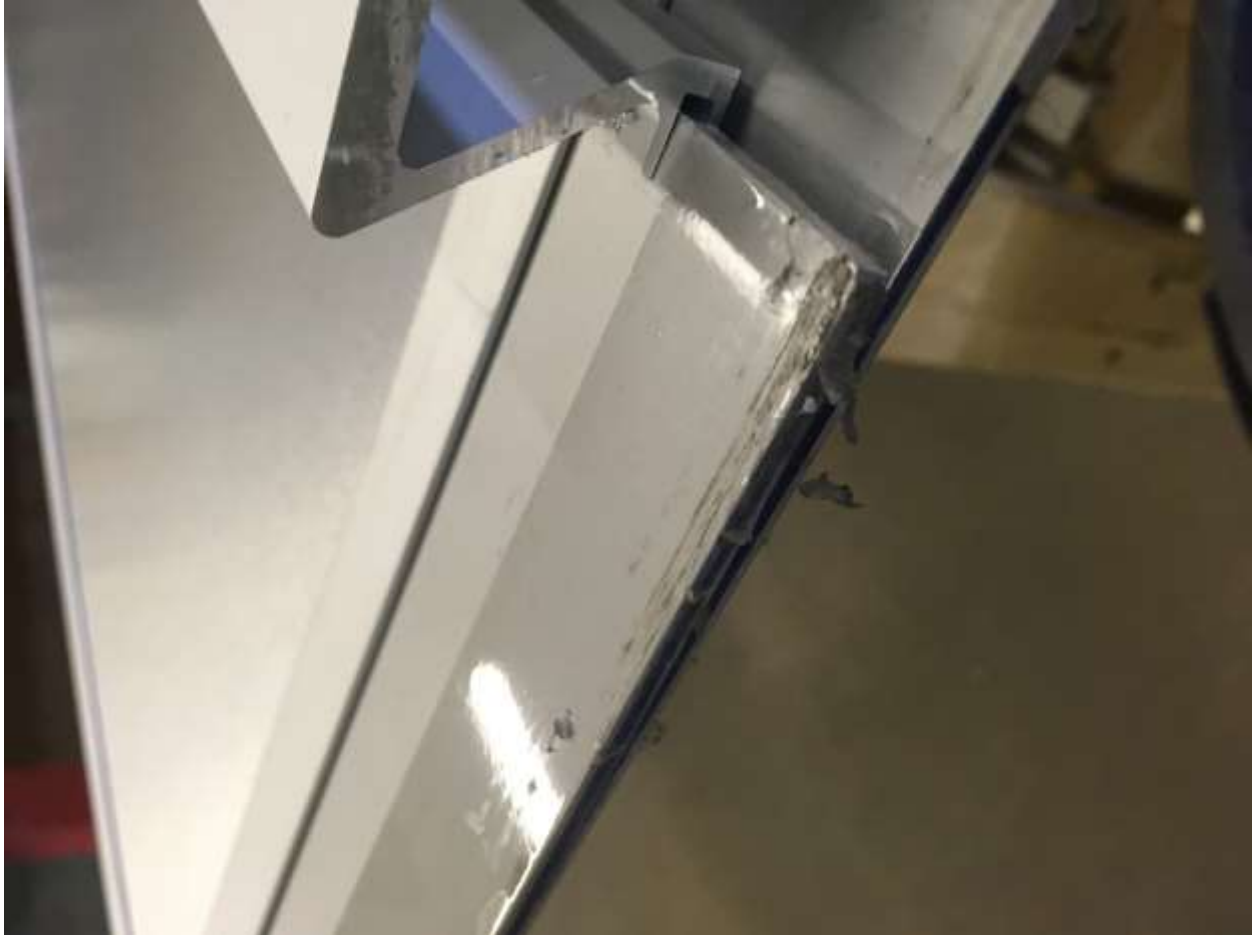
As part of the assembly there is a low friction polymer film at the bottom of each panel. One concern during the design stages was whether this film would hold up well over numerous cycles. An image of the worst panel is shown below and as can be seen the film is still intact on the running surfaces. There is some degradation on the bottom of one edge but it is believed this can be attributed to some debris in the lower sill/ track and it did not affect performance in an appreciable way. Further, this film is easy to remove and then re-apply should it become a problem over the life of operation.

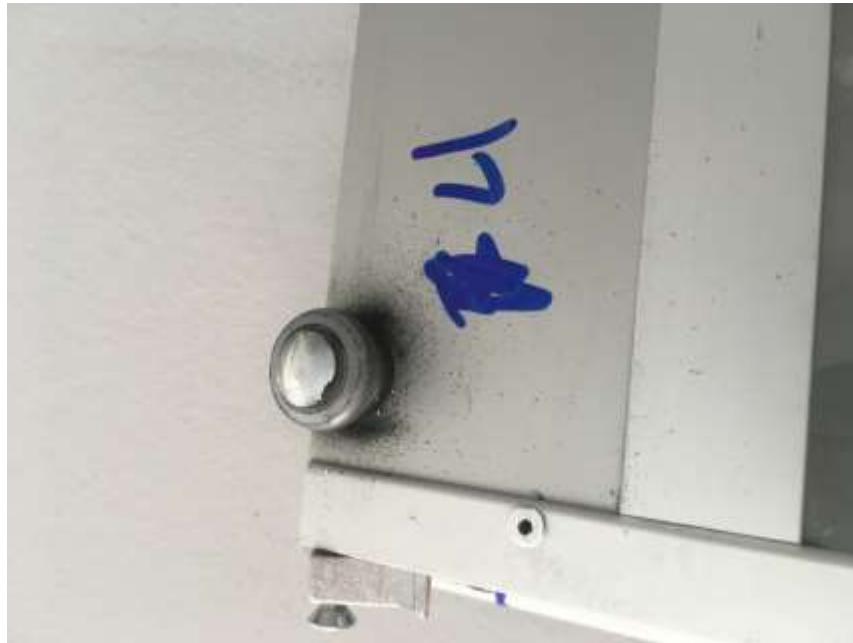
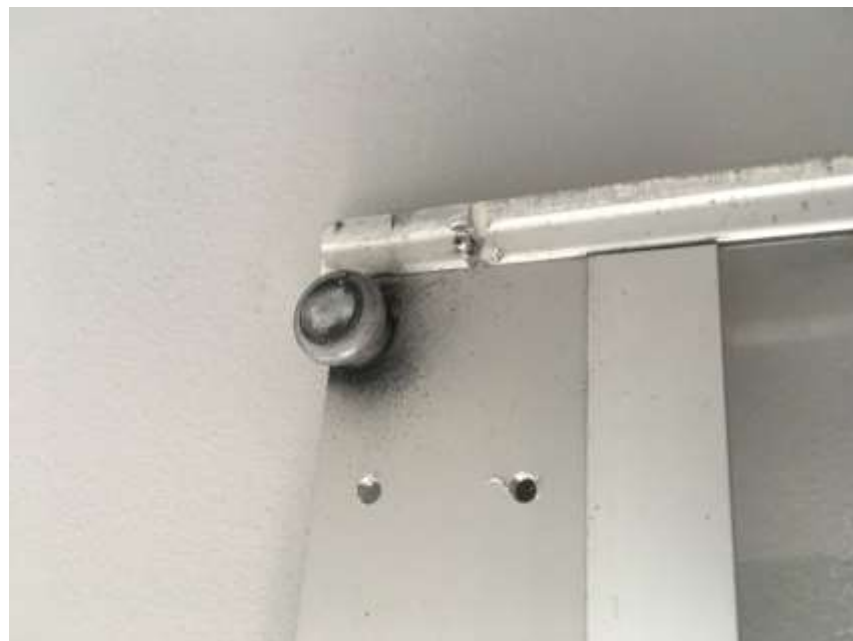
The wheels on panel #4 had significant black powdery residue around them where this was not present on any others. It is inconclusive where this is coming from but it may be a result of some late stage drilling operations during set up that allowed for some aluminum drilling residue to be present near the end of the track for panel #4.

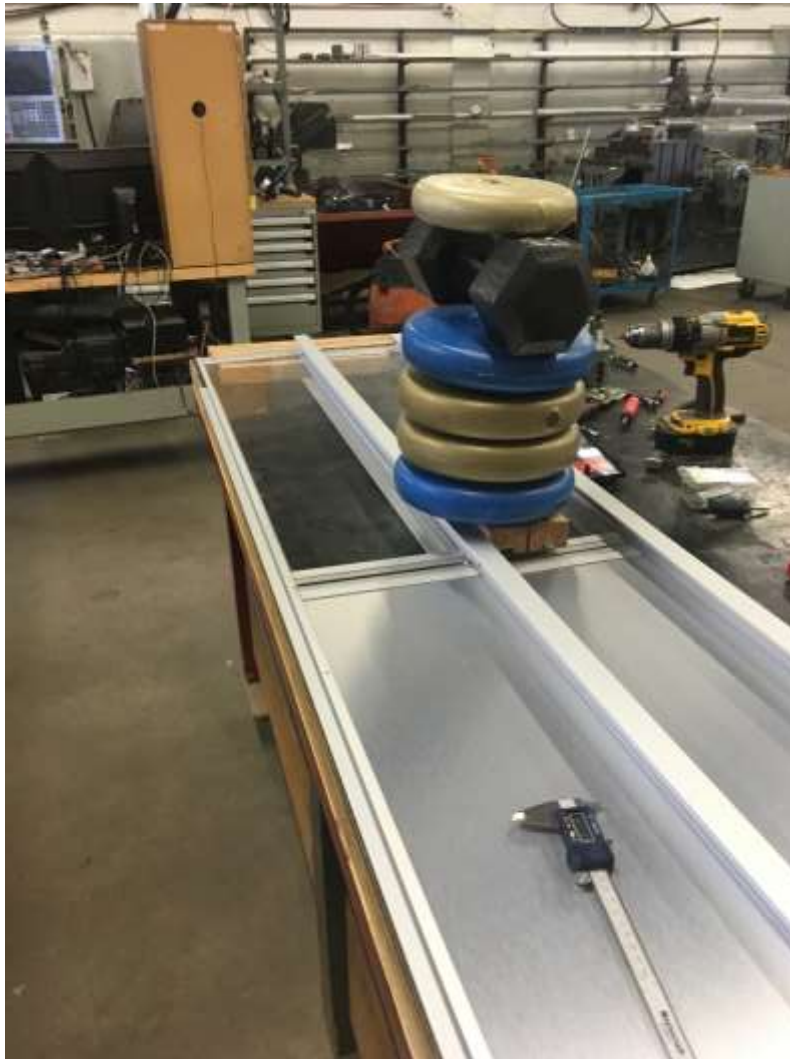
Panel #3 and #4 were used for load testing and an image of that set up is shown below. This is the same testing as completed on other panels during final prototyping and is only being used to confirm that panels will still meet the 0.75in deflection at 75lb load acceptance criteria required by ASME A17.1/ CSA B44 – 2016 safety code.

Deflection on the acrylic portion of the panel was 0.458in and on the aluminum outer edge it was 0.347in. Load was applied on a 4in x 4in wooden puck eccentrically.
